## LIMITED-SCOPE PROPERTY CONDITION INSPECTION REPORT

# Building Envelope, Foundation Perimeter, Sub-Area, Systems & Evidence of Wood-Destroying Organisms

Single-family residence · Northern California

Redacted specimen · 119 checklist points · 55-plate photographic record

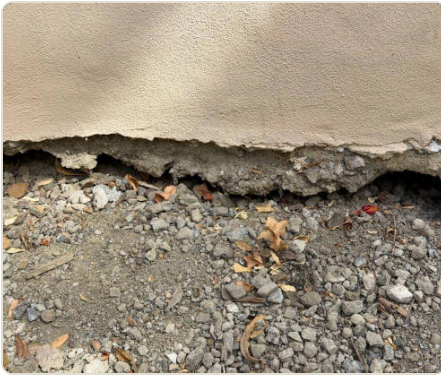
**Plate 12.** Base coat overhanging open voids; soil removed from beneath the wall line.

**This is stated as the more probable explanation, not as a determination, and it should not be relied upon as one.** Gaps beneath an exterior finish do not by themselves establish that soil has been removed from beneath a footing: the footing configuration and depth were not verified, no soil or footing was probed, no excavation was measured, and the drainage termination was not traced. Confirming the cause requires those checks together with the owner's account of any recent work at the perimeter.

The sequence, however, does not depend on settling the question: **roof water should be carried away from the base before soil is reinstated or finishes are patched**, since work completed while water still discharges there can be expected to fail in the same places.

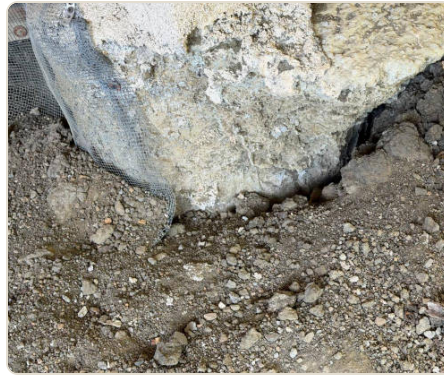
**Plate 18.** Corner with lath reinforcement exposed and hanging free, concrete edge broken away.

On either reading, three things hold: soil in direct contact with wall base and framing (plates 21, 53) is a moisture and pest path and should be cut back; the exposed lath at plate 18 should be protected before it corrodes further; and roof water must be carried away from the base rather than discharged at it.

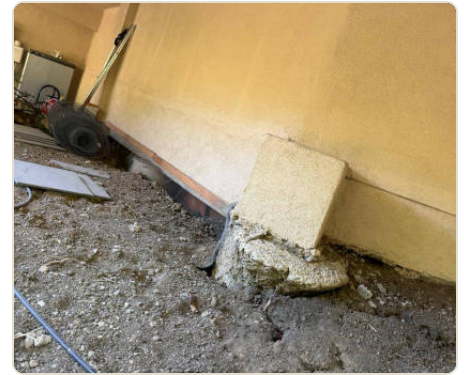
**Plate 52.** Interior space with a bare soil floor; wall base above a broken, spalled foundation corner.

**Open voids and displaced soil were observed beneath portions of the exterior finish and adjacent to the visible foundation perimeter.** A nearby downspout discharges at the wall base and may contribute to erosion; however, **the cause of the voids was not established.** The footing configuration was not exposed, and this inspection did not determine whether the voids extend beneath the footing or affect bearing support. Confirm whether recent excavation occurred, correct roof-water discharge, and have the affected areas evaluated by a qualified foundation contractor or structural engineer before soil is reinstated. Plates 12–21, 50, 52–53.

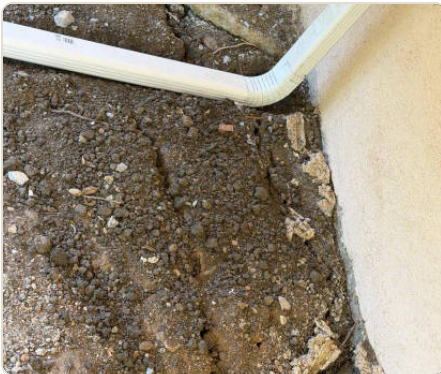
**Plate 17.** Downspout turning to discharge at the wall base; soil below scoured into a trench.

Then soil is being removed from beneath the perimeter and the cause is still running. Plate 17 shows a downspout discharging directly at the base with a scour trench below it, which is a mechanism capable of producing this. That calls for a licensed contractor and a structural evaluation to establish whether bearing support has in fact been affected.

**Roof water discharges at the foundation and soil is banked in direct contact with the wall base.** A downspout turns to discharge at the base with a scour trench beneath it (plate 17); a loose downspout section lies on the ground (plate 20); soil and organic debris sit against the wall base at several points (plates 21, 53). This is the mechanism most likely to be driving the perimeter condition above, and it is correctable independently of resolving its cause.

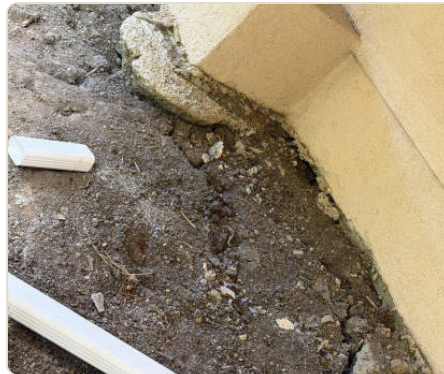
**Plate 20.** Base coat broken and crumbling at a corner; loose downspout section on the soil.

Then it is a temporary construction condition. It still needs protection from rain while open, and the soil must be reinstated and compacted with grade sloped away on completion — but it is not a defect in the building. Loose downspout sections and debris in the trench (plates 20, 50) are consistent with work under way.

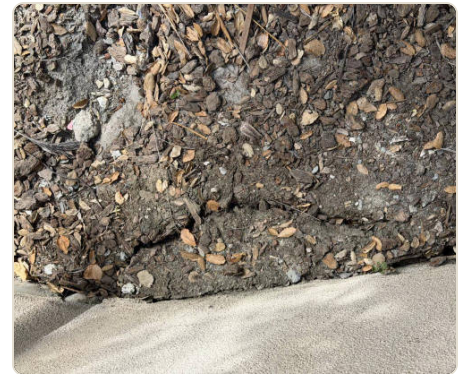
**Plate 21.** Soil and organic debris banked in direct contact with the wall base.

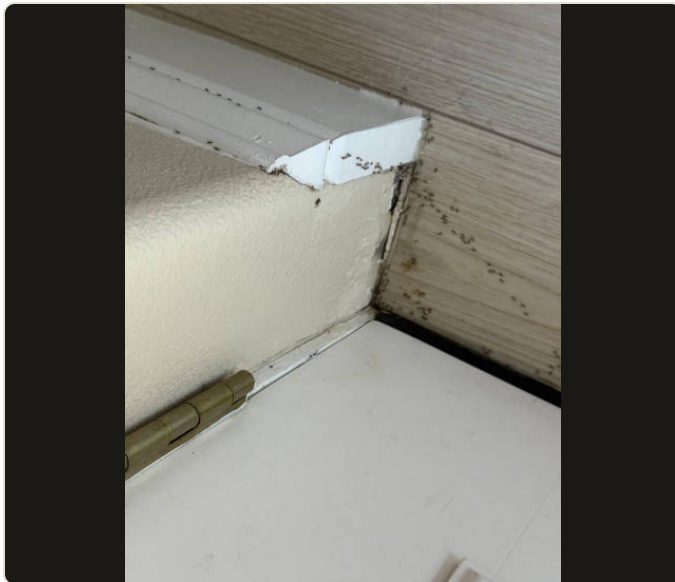
Plate 49 • Exterior door frame. A substantial number of small insects on and around the painted frame and jamb, concentrated at an open joint in the trim. Dirt streaking runs below the joint. Photographed as found; no specimen was collected.

Both surface observations are recorded because of **where they are, not what they might be**. The insects at plate 49 are not simply present on a wall; they are concentrated at an open joint in wood trim, which is the point at which an insect would enter a wall assembly. The deposit at plate 07 sits on a vertical face below a roof drainage outlet, where loose material would not normally accumulate and stay.

**Evidence consistent with termite or other wood-destroying organism activity at three locations, and a termite and wood-destroying organism inspection is strongly recommended.** Insects concentrated at an open joint in exterior door trim (plate 49); a granular pellet-like deposit adhering to stucco at an arch head (plate 07); wood at the mudsill accepting a knife probe with little resistance (plates 27–29). No species identified, no active infestation asserted or excluded, no treatment recommended. Inspection by a registered structural pest control company — a licensed Branch 3 operator or an appropriately licensed field representative — is strongly recommended for those determinations.

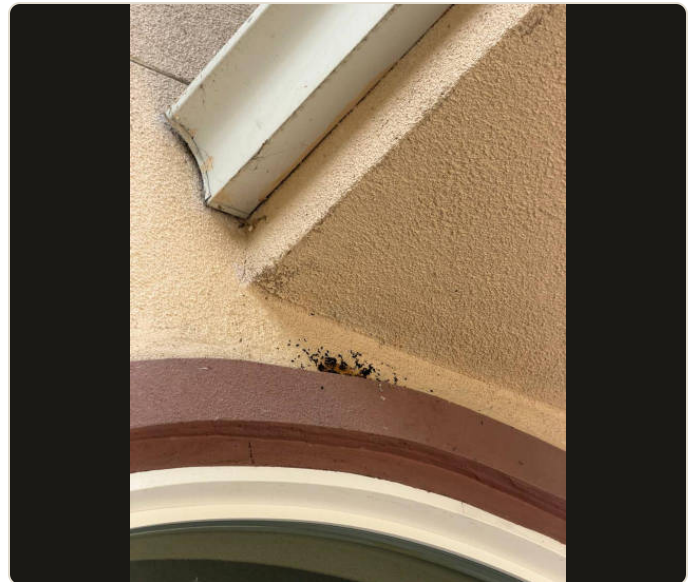
Plate 07 • Stucco at an arch head, below a gutter end. A dark granular deposit adhering to the wall face in a small cluster, individual particles pellet-like at this magnification.

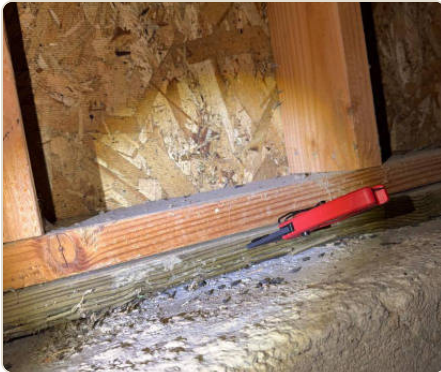
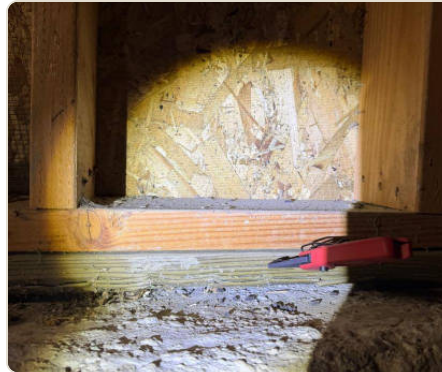
Plate 27. Mudsill on the foundation top with a heavy white crystalline bloom on the concrete below it.

Plate 28. The same deposit in an adjacent framing bay, extending onto the soil.

**The white bloom on the concrete (plates 27–28) is a mineral deposit, not growth.** Deposits of this kind form where water passes through concrete or masonry, dissolves salts within it, and evaporates at the face leaving the salts behind. Its significance is that it is a record of water having moved through that foundation repeatedly — it does not indicate that the concrete is wet now, and no moisture reading was taken at these locations.

This bears on how the rest of this section reads. The mineral bloom in plates 27–28 records water movement at the foundation, and **the probe softness occurs at those same locations** — a relationship worth investigating, though this report does not establish that one caused the other. The mudsill transfers wall load to the foundation and carries the sill anchorage, which is why softness there warrants evaluation that the same condition in a non-bearing member might not.

Wood at the mudsill accepted a knife probe with little resistance at the locations shown in plates 27, 28 and 29. Sound structural softwood normally resists a blade. **No strength loss was measured and the depth and extent of the softness were not established.** The observation matters because a mudsill transfers wall load to the foundation and carries the sill anchorage. Cause was not determined — fungal decay and wood-destroying organism attack can both produce softness of this kind and probing does not separate them. A registered structural pest control company and, where support is affected, a structural engineer should assess before any repair is scoped.

**Crystalline mineral deposits along the foundation below the mudsill in two framing bays** (plates 27–28). A record of water having moved through the concrete repeatedly. It does not establish that the foundation is wet now — no moisture reading was taken there — but it corroborates the drainage findings above and the bays should be re-checked once perimeter drainage is corrected.

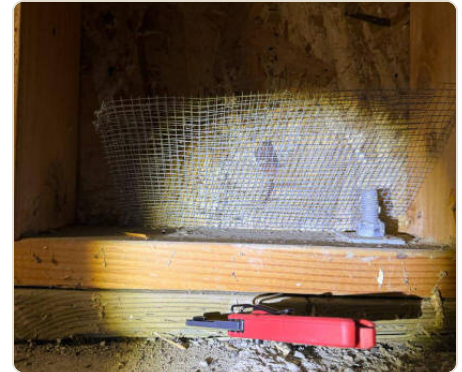
Plate 29. Screened foundation vent, mudsill, and an anchor bolt with nut and washer in place.

Plate 29 records a **screened foundation vent intact and a visible anchor bolt with nut and washer in place** at that location. **This describes what was visible only.** Bolt size, embedment, spacing, torque and compliance with any standard were not evaluated, and no opinion is offered on the adequacy of the anchorage. It should also be read alongside the probe result below: the bolt passes through a member that accepted a knife blade with little resistance.

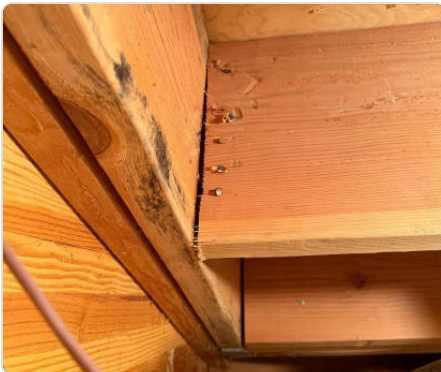
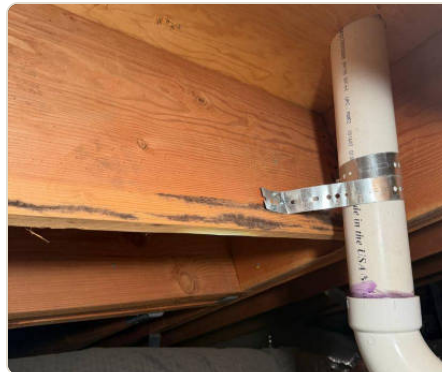
Plate 38. Black patchy staining along a beam edge at a framing bearing point.

Plate 40. Dark staining running along a joist edge next to a strapped PVC line passing through framing.

**The dark staining on framing (plates 38, 40, 43) is on wood, and its appearance is consistent with fungal growth on material that has been wet.** No sampling was performed, so this report does not identify it as mold, does not name any organism, and offers no opinion on air quality or health. The pattern is worth noting: it appears at bearing points and alongside a pipe penetration, which are the places water collects and sits. The stained and split decking at plate 44 is a separate location again.

**Dark staining on sub-area floor framing at three locations, and a stained, split area of plywood decking.** At beam bearing points and alongside a pipe penetration (plates 38, 40, 43), and on decking (plate 44). Appearance is consistent with fungal growth on material that has been wet. No sampling was performed; this report does not identify it as mold and offers no opinion on air quality or health. Source of the wetting was not determined.

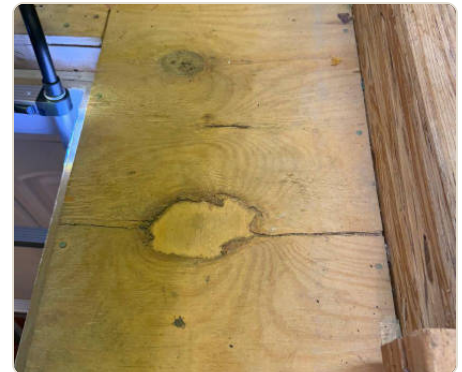
Plate 44. Plywood deck with a defined stained patch and a split running from it along the grain.

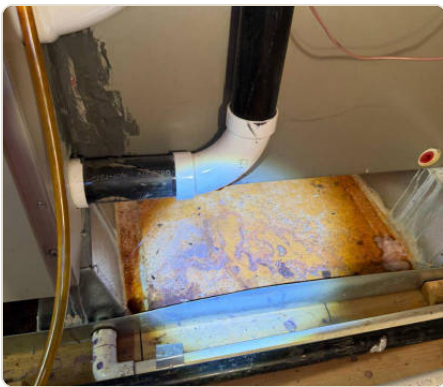
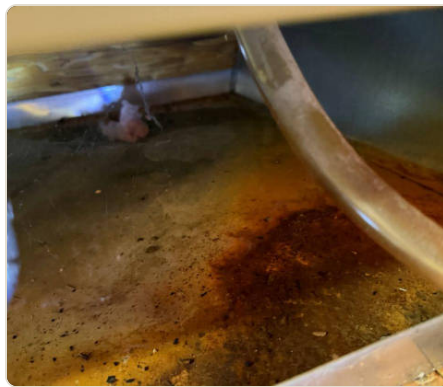
**Plate 42.** The pan base is rusted and stained across most of its area; black ABS elbow and white PVC enter above it.

**Plate 39.** Close view inside the pan: heavy orange rust, dark deposits, cobweb and debris.

A drain pan exists to catch a leak and carry it away, and its condition is a record of what has passed through it. **Rust across most of the pan base means water has stood in it, and stood long enough and often enough to corrode the metal.** That is evidence of a past or ongoing discharge, not of a pan defect in itself. Two things follow that this inspection did not establish: whether the discharge is still occurring, and whether the pan — now corroded — would still hold and drain a leak rather than pass it through to the deck below.

**The appliance drain pan is rusted across most of its base.** Rust and dark deposits over the majority of the pan area (plates 39, 41–42, 45), indicating water has stood in it repeatedly. Whether a discharge is ongoing, and whether the corroded pan would still contain and drain a leak, were not established. The pan, its drain line and the appliance above it should be assessed by a plumber or HVAC contractor.

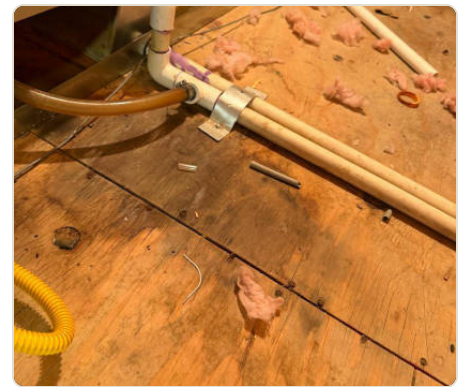
**Plate 37.** Platform deck: loose insulation fragments, pipe offcuts and metal debris left in place.

No moisture reading was taken at the platform deck, the appliances were not operated for the purpose of testing the pan, the pan drain line was not traced to its termination, and the appliance identity and age were not recorded. The construction debris at plate 37 is a separate and minor matter, but debris of that kind on a platform obstructs the pan and hides the early signs of a leak, and should be cleared.

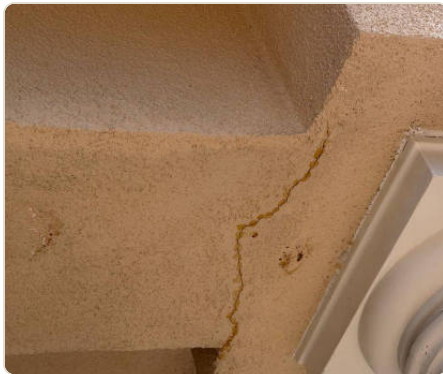
**Plate 10.** Crack down a beam face beside a column, with amber-brown staining along its full length.

**Plate 10 is the one to look at first.** The crack itself is unremarkable; the amber-brown staining following it for its whole length is not. Staining along a crack indicates that water has been running in it and carrying dissolved material out to the face, which means the crack is a water path into the assembly rather than a surface blemish. **Plate 51 is the second,** because a crack passing through a capital block at a beam bearing point sits where load is transferred, and that location gives it a significance the same crack elsewhere would not have. **Plate 09 is the third,** being immediately adjacent to a downspout.

**Cracking in the exterior finish at a porch beam, carrying amber-brown staining along its length, and cracking in the finish at a column capital where a beam bears.** Plates 10 and 51. **These are observations of the finish material; the framing behind it was not exposed and its condition is unconfirmed.** The staining suggests water is present in the crack, which would be a reason to look behind the finish, but the significance of the staining was not established. Neither crack was measured or monitored, so whether either is progressing is unknown. Have the beam and the column bearing point evaluated, with the finish opened where necessary.

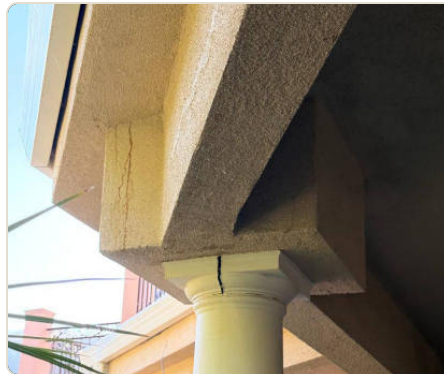
**Plate 51.** Beam over a column; a crack passes through the capital block at the bearing point.

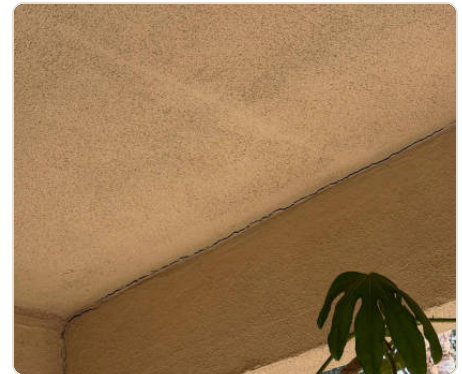
**Plate 11.** Long open crack along a soffit-to-beam junction, running the length of the frame.

**Cracking in hardscape, soffits, stucco and a planter curb at several locations** (plates 02–06, 08–09, 11, 54–55). Cracking of this kind is common and largely cosmetic. Sealing open cracks and joints keeps water out of the assemblies behind them; the joint between wall base and pavers (plate 04) and the stucco crack beside the downspout (plate 09) are the two to attend to first.

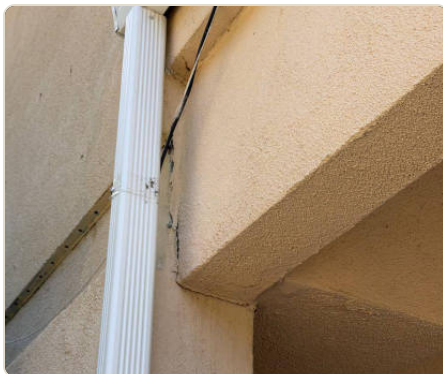
**Plate 09.** Vertical crack in stucco alongside a downspout, descending from the beam end.

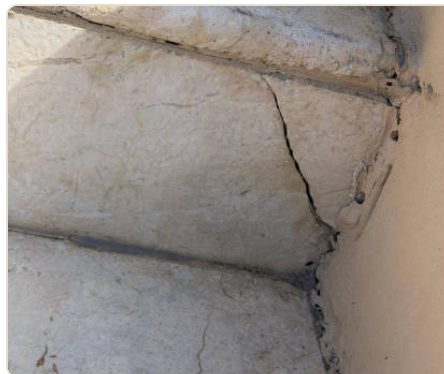
**Plate 03.** Stone-clad step, tread cracked through and separating at the wall junction.

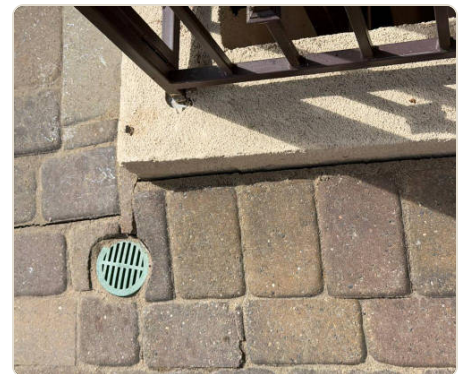
**Plate 05.** Round area drain set in pavers beside a step; pavers cracked at the grate.

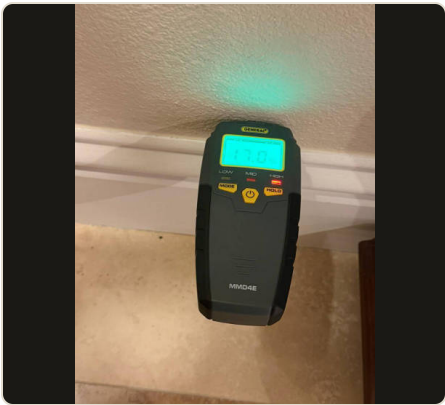
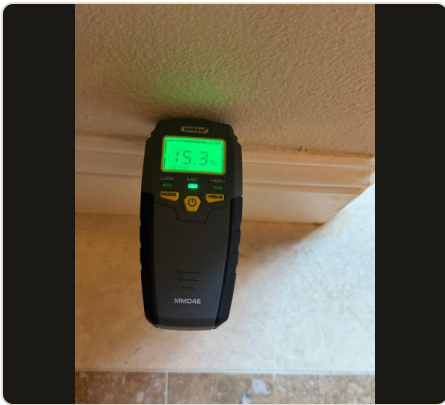
Plate 24 — 17.0%. Red HIGH lamp lit.

Plate 25 — 15.3%. MID lamp lit.

Because the substrate was not recorded and the meter was set to its wood scale, these readings cannot be interpreted as the moisture content of the tested material unless that material is confirmed as solid wood. The readings and differences between them are recorded as instrument outputs only. **No elevated-moisture condition is established from these measurements.** Re-test using the appropriate material setting and comparison readings from unaffected material of the same type.

**Moisture meter readings of 17.0% with the HIGH indicator lit, and 15.3% adjacent, recorded at a wall-to-ceiling junction** (plates 24–25). Both were taken on the meter's wood scale. **The substrate was not recorded and cannot be established from the photographs, so neither the readings nor the difference between them can be relied upon.** The manufacturer specifies the wood scale for solid wood and a separate building-material setting for drywall, plaster and similar substrates; a wood-scale value returned on a non-wood material is not that material's moisture content, and two such values are not a valid comparison. These are reported as instrument output only. Re-check with the material identified, the appropriate setting selected, and readings taken at comparable unaffected locations for reference.

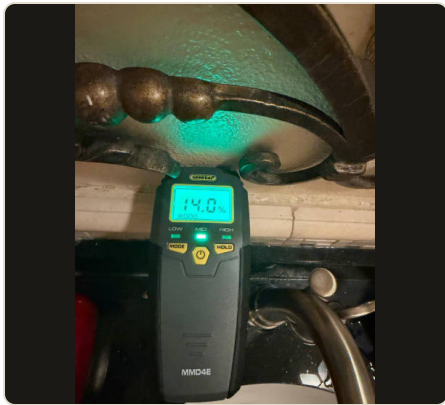
| PLATE | READING | INDICATOR | POSITION AS PHOTOGRAPHED |
|---|---|---|---|
| 23 | 14.0% | MID | At a plumbing fitting or valve beneath a fixture. |

Plate 23 — 14.0%. MID lamp lit, at a plumbing fitting.

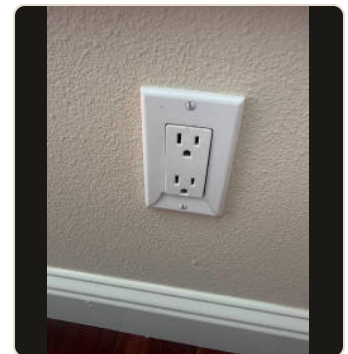
Plate 32. Cover plate  
cracked through.

The cracked cover plate at plate 32 is a genuine if minor defect: a broken plate leaves an opening into the device box and should be replaced. No conductor was disconnected, no circuit traced, no conductor material determined, and no receptacle other than the one shown was tested.

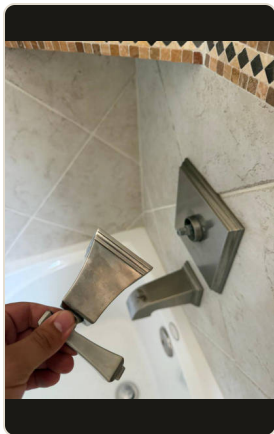
**Plate 33.** Tub and shower valve with the handle detached; stem and escutcheon remain on the wall.

The tub and shower valve handle is detached from the valve stem. A control that comes away in the hand is a defect in service: the fixture cannot be reliably shut off by an occupant, and the exposed stem invites the use of pliers, which damages the valve. It should be refitted or replaced by a plumber, and the valve checked for the cause — a stripped handle broach or a corroded stem — rather than simply pushed back on.

**The tub and shower valve handle is detached from the valve stem** (plate 33). The fixture cannot be reliably operated or shut off by an occupant. Refit or replace, and establish the cause at the valve rather than simply refitting the handle.

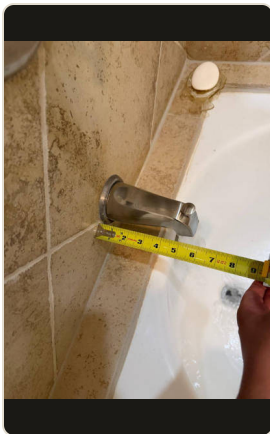
**Plate 34.** Tub deck at the spout. Grout and tile substantially discolored throughout this enclosure.

The tile and grout in this enclosure are **substantially discolored across the field, not merely at the joints**. Discoloration of this extent in a wet enclosure is consistent with prolonged surface moisture and with a grout and sealant system at or past the end of its service life. **No sampling was performed and this report does not identify the discoloration as mold**; it records appearance only. No moisture reading was taken in this enclosure, the shower was not flood-tested, and no water was applied for testing, so nothing here establishes whether water is passing behind the finish.

**Tile and grout substantially discolored throughout the bathroom enclosure** (plate 34), consistent with a grout and sealant system at or past the end of its service life. Appearance recorded only; no sampling performed and no organism identified. Regrouting and resealing is ordinary upkeep, but should follow rather than precede any moisture testing of the enclosure.
