## LIMITED-SCOPE PROPERTY CONDITION INSPECTION REPORT

# Building Envelope, Foundation Perimeter, Sub-Area, Systems & Evidence of Wood-Destroying Organisms

Single-family residence · Northern California

Redacted specimen · 119 checklist points · 55-plate photographic record

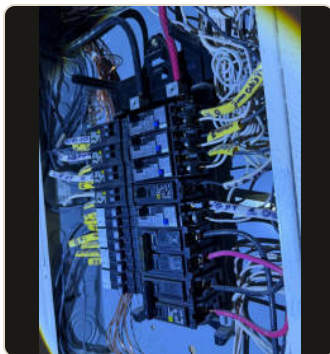
Plate 35. Panel interior,  
deadfront removed.

The panel deadfront was removed to view the interior and reinstated afterwards. A two-pole main breaker and branch breakers rated 15 to 30 amps were present, **including several AFCI devices**, with neutral and equipment bars to both sides and hand-written circuit identification tags on the conductors. **No defect is recorded at the panel:** no scorching, melted insulation, corrosion or water staining was visible on the interior, breakers appeared seated, and the enclosure was dry. Circuit tagging being present is a point in the installation's favor.

**Electrical panel interior — no defect observed in the components visible with the deadfront removed.** This is limited to what was visible; it is not a clearance of the electrical system, and the receptacle result below remains undetermined. No scorching, corrosion or water staining; enclosure dry; breakers appeared seated; AFCI devices present and circuits tagged (plates 35–36). Conductor material was not determined and cannot be determined from photographs, so this is not a statement that no aluminum branch wiring is present. Supply voltage at the one receptacle tested was normal at 122 VAC, though the wiring configuration there was not determined (plate 22).

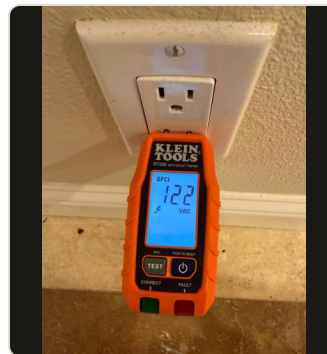
Plate 22. RT250 tester, 122 VAC.

or open ground condition delivers normal voltage — so nothing here should be read as clearing that receptacle. It should be re-tested and the field result recorded. **One receptacle was tested out of an unknown total; the wiring of the property as a whole was not assessed.**

5. Have the drain pan, its drain line and the appliance above it assessed, and clear the platform of debris.
6. Re-read the three moisture positions with the substrate identified and the correct instrument scale, with comparison readings in sound material nearby, and re-test the receptacle at plate 22.
